# Coastal Change on PEI

Using Local Knowledge

May 24, 2012

Winter River – Tracadie Bay Watershed  
Association

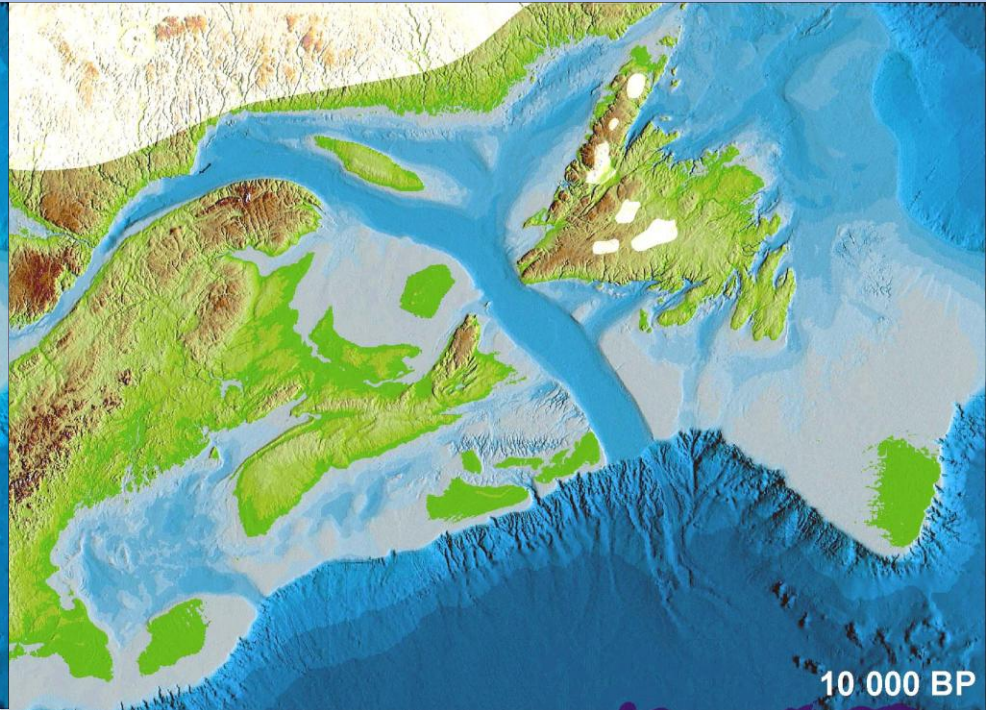
Atlantic Canada – Present day  
-From D. Forbes, 2009

Atlantic Canada – 10,000 years ago –  
PEI Not an Island  
- From D. Forbes, 2009.

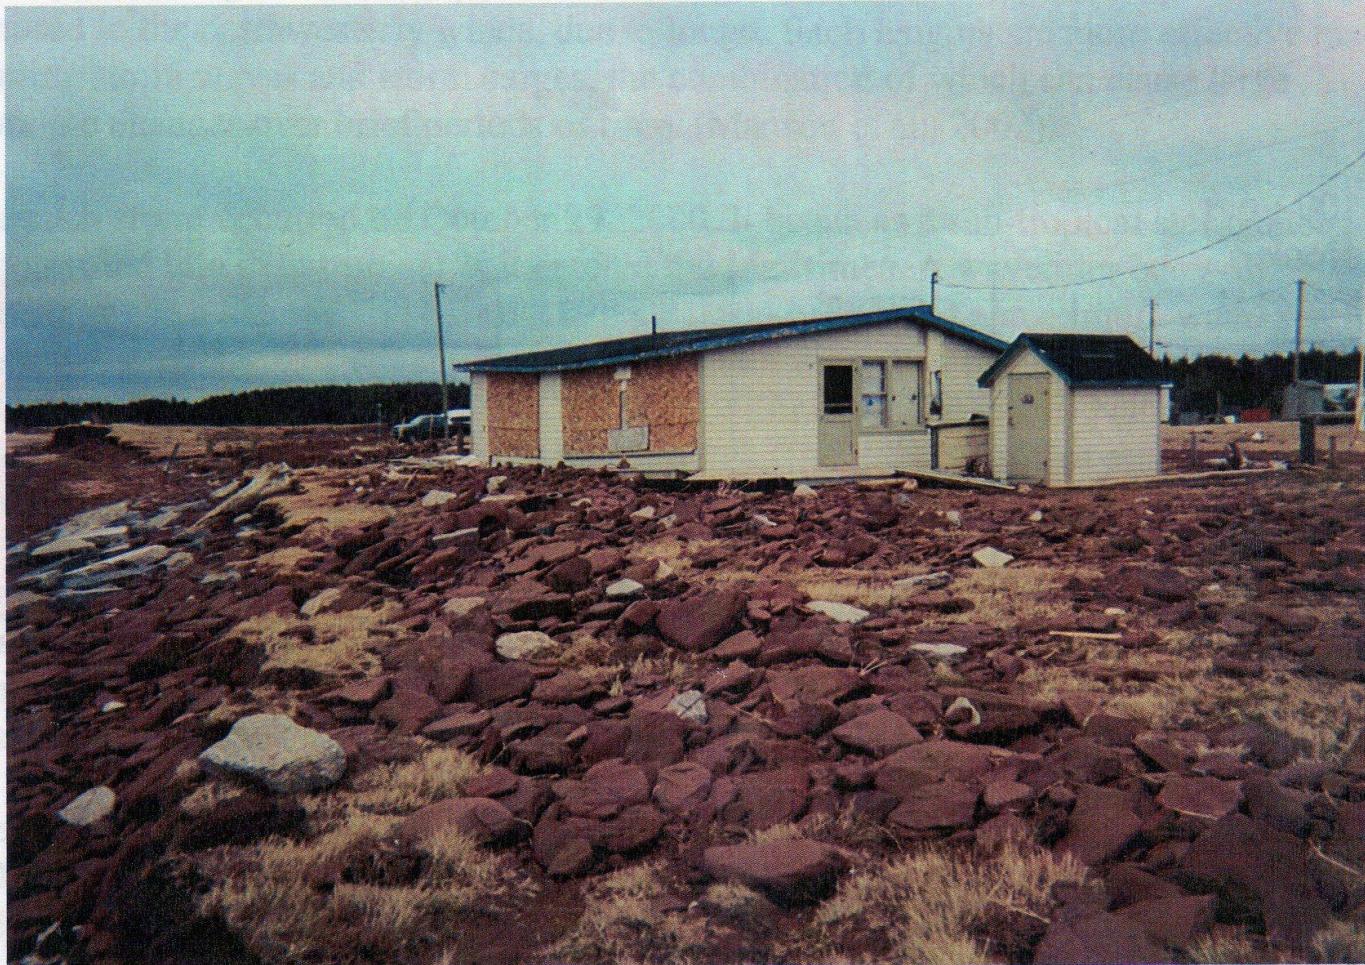
Figure 2. Cottage destroyed in the November 2001 storm. The owner was quoted in The Guardian “when the waves came crashing through the front windows, it was time to get out”

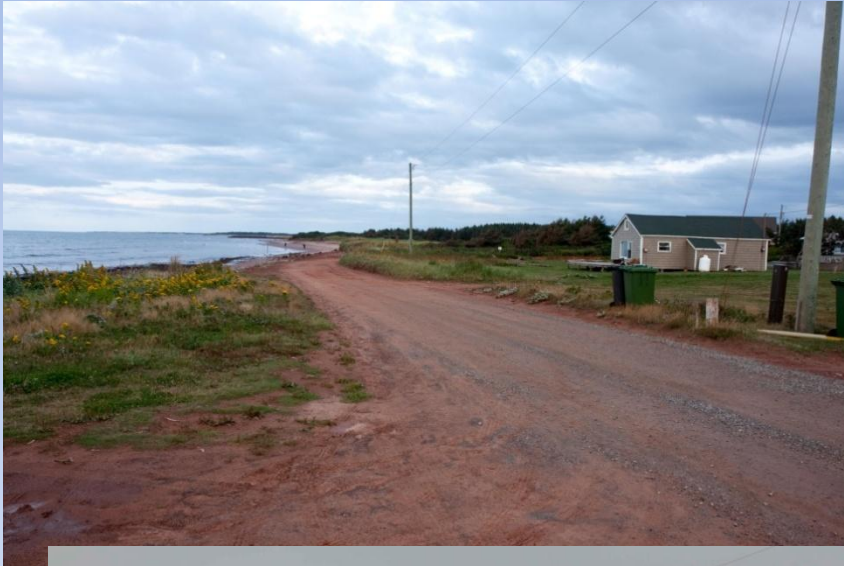
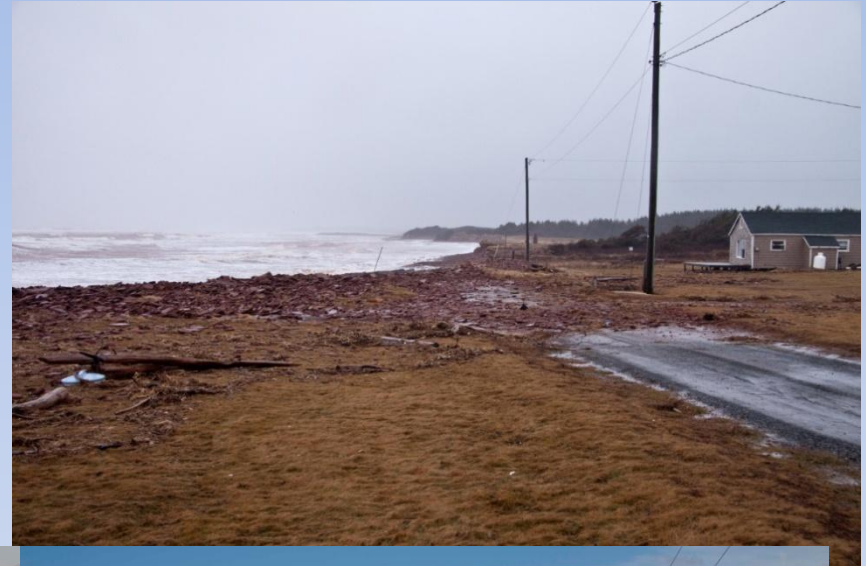
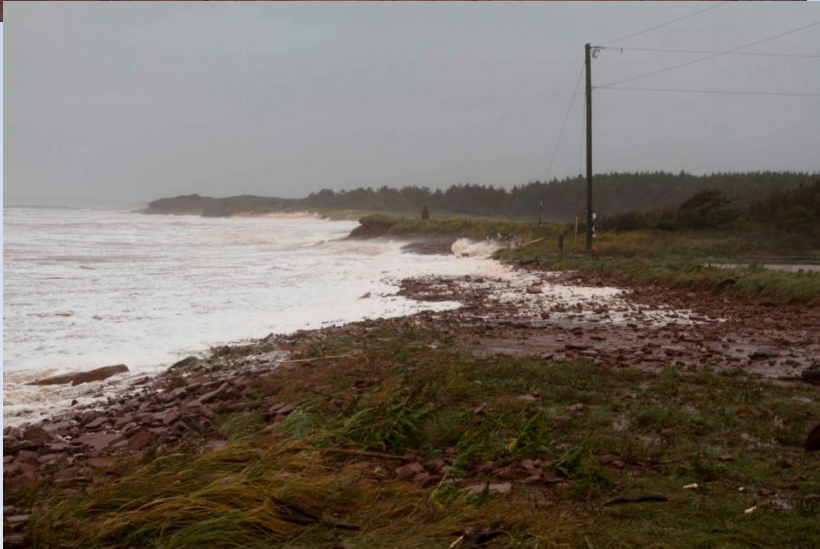
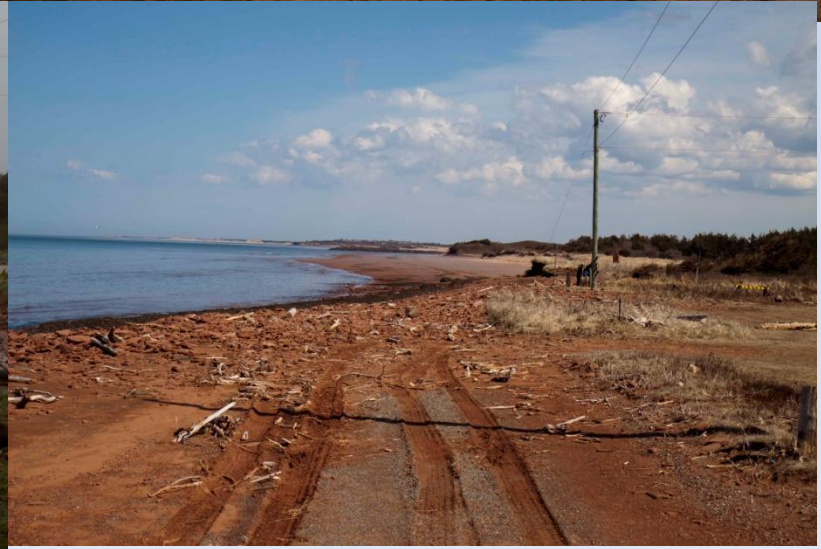
# Coastal Erosion at Savage Harbour – Surfside Lane under attack

Sept. 13, 2010

Dec. 22, 2010

Oct 5,  
2011

April  
11,  
2012

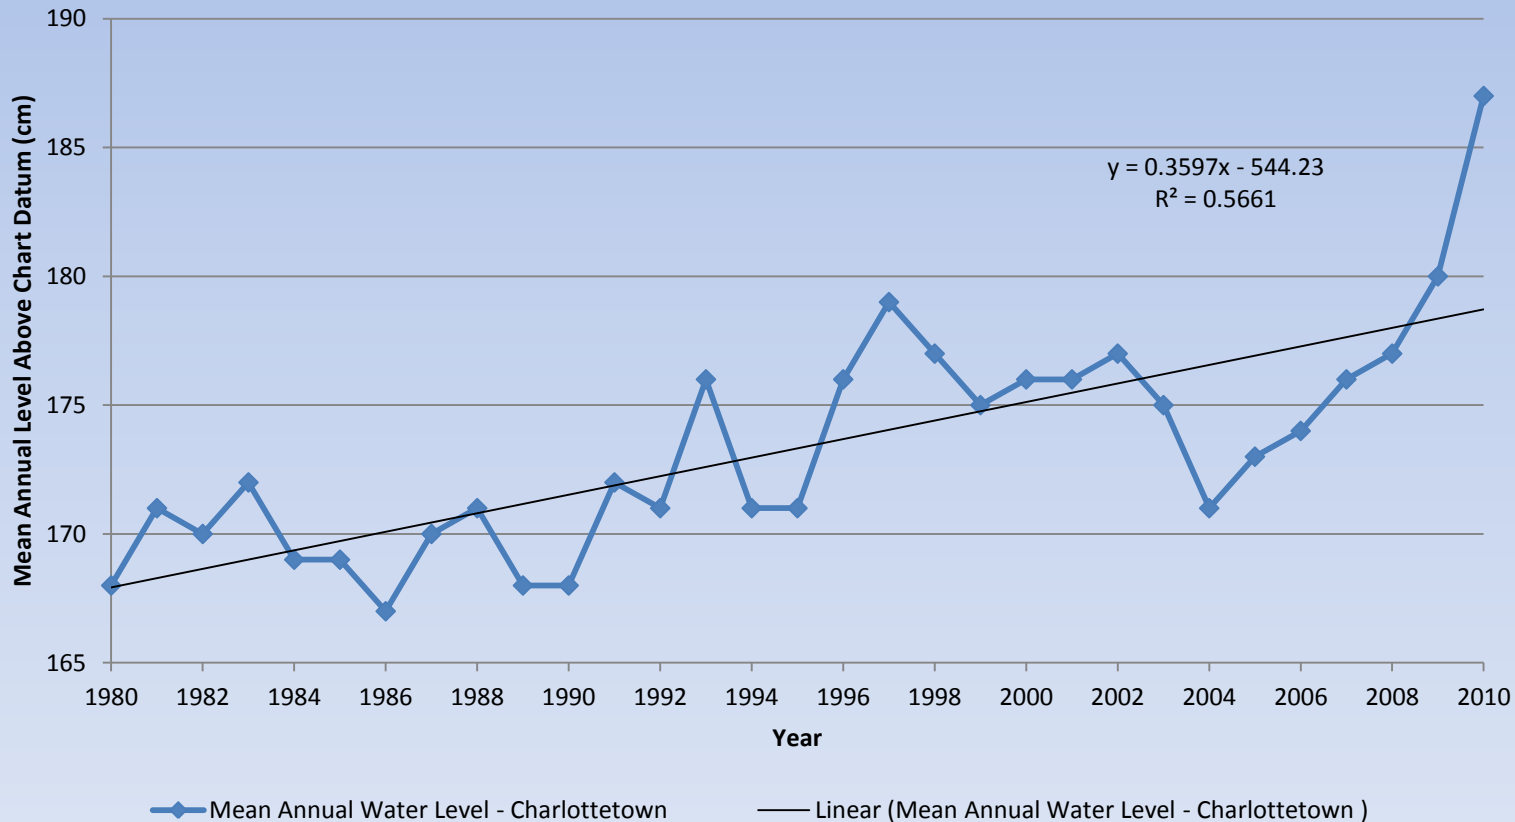
# *Charlottetown – 1980-2010*

## *Rate of Increase 36 cm/century*

### Mean Annual Water Level - Charlottetown

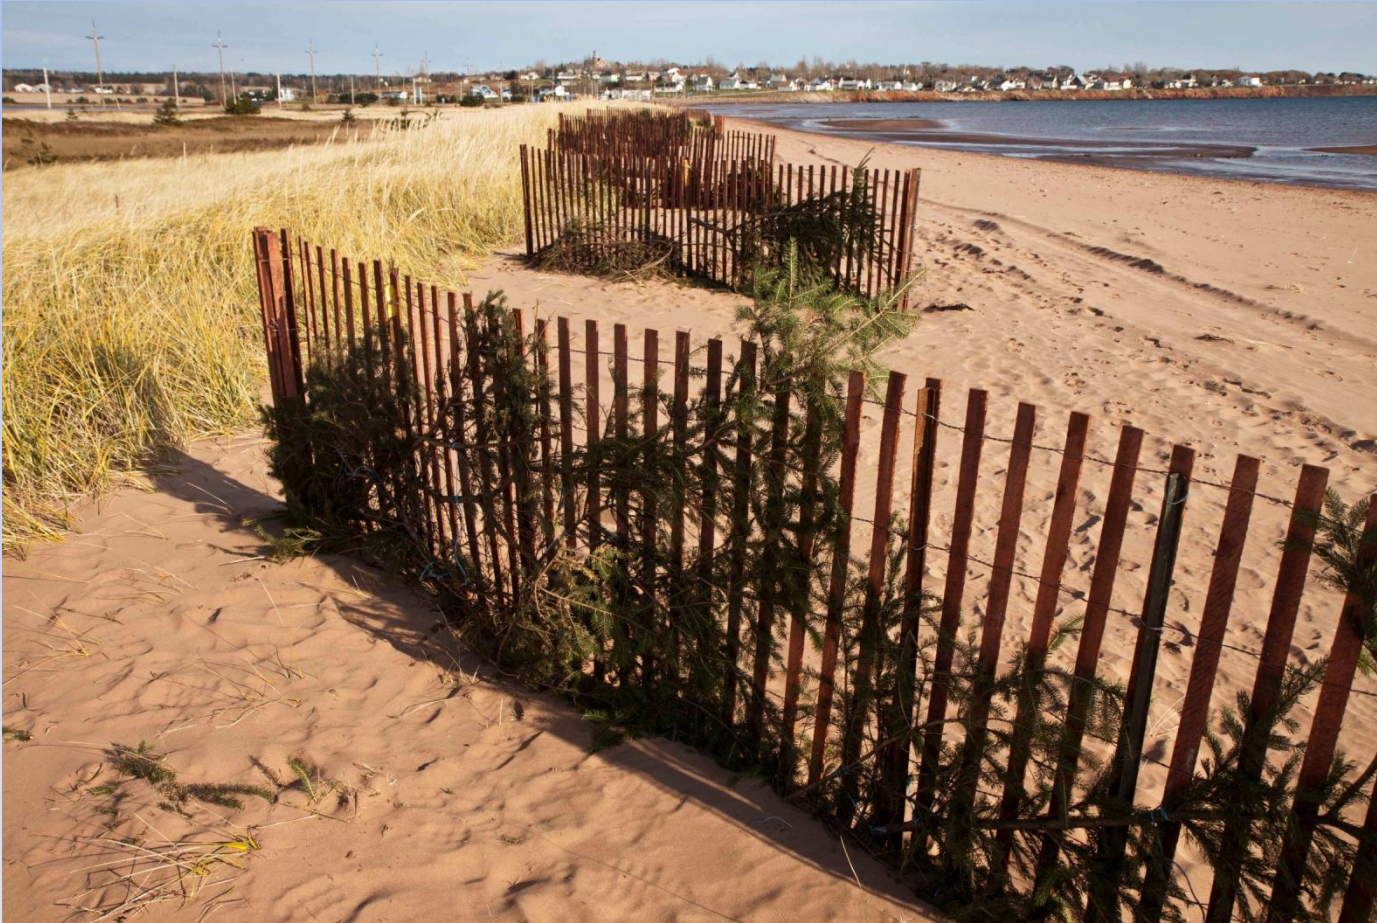
# Beach Nourishment Technique

Souris Wildlife Federation sand nourishment method to build up sand on the Souris Causeway

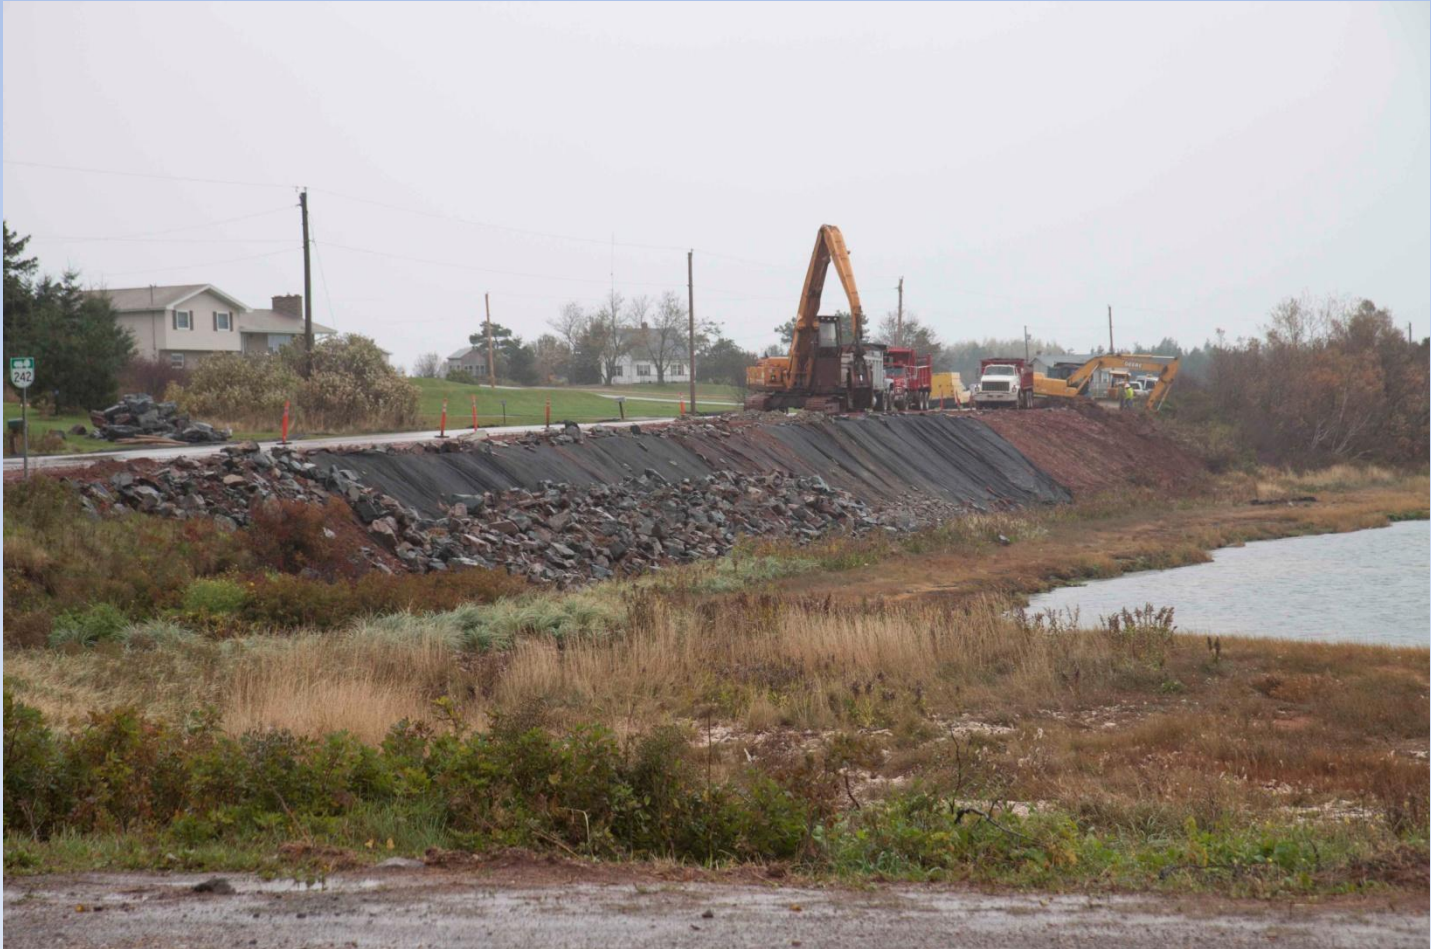
# Placing Armour Rock at Cymbria – Hard Method - TIR

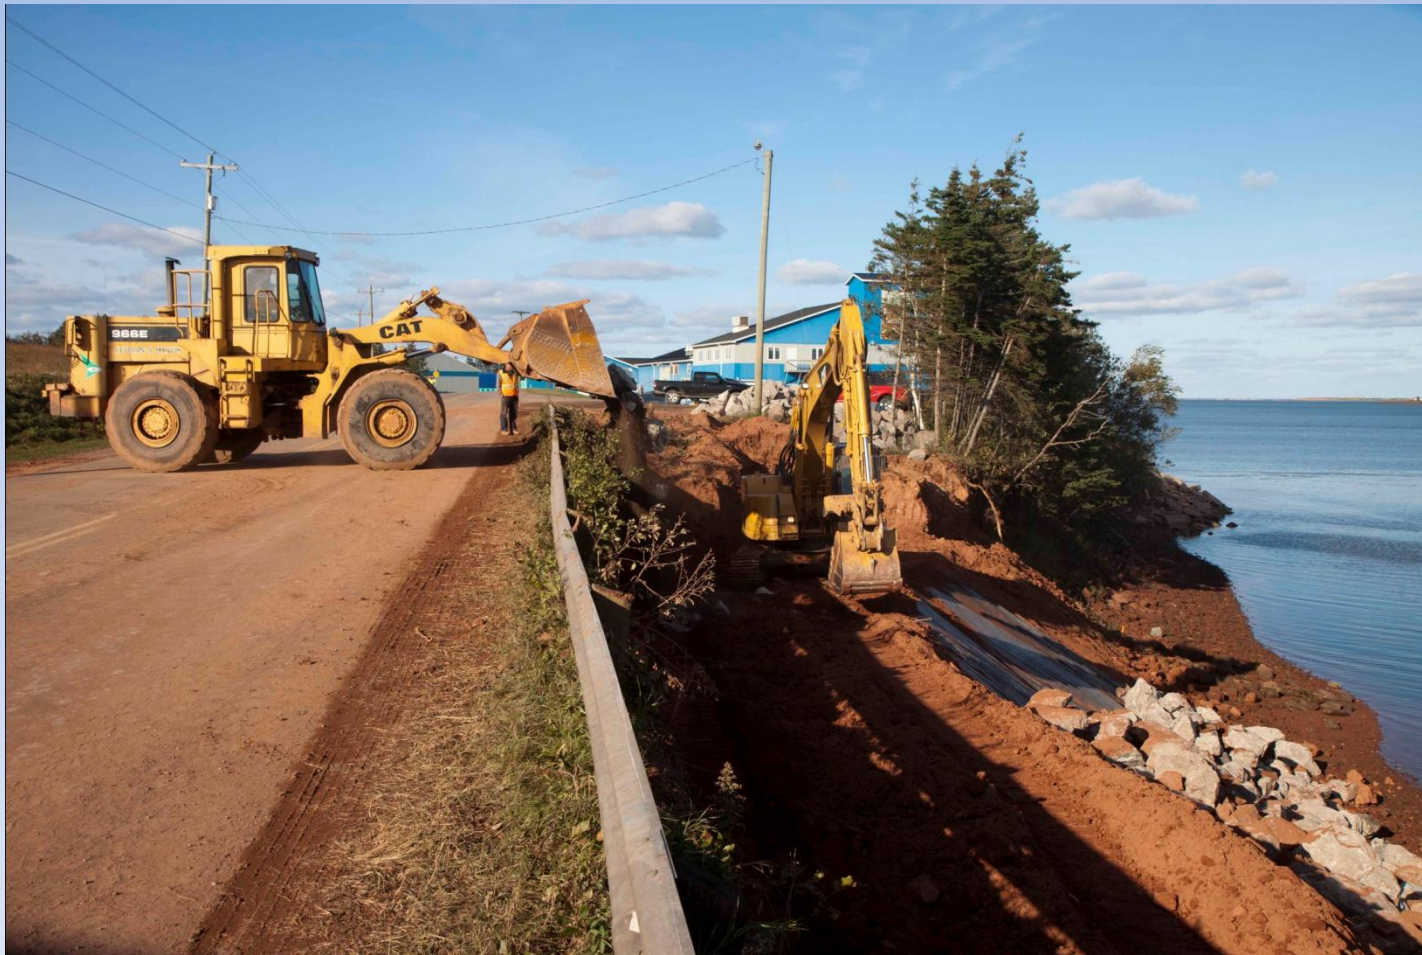
# Springbrook Shoreline Protection – TIR – Oct. 2011 – Hard method

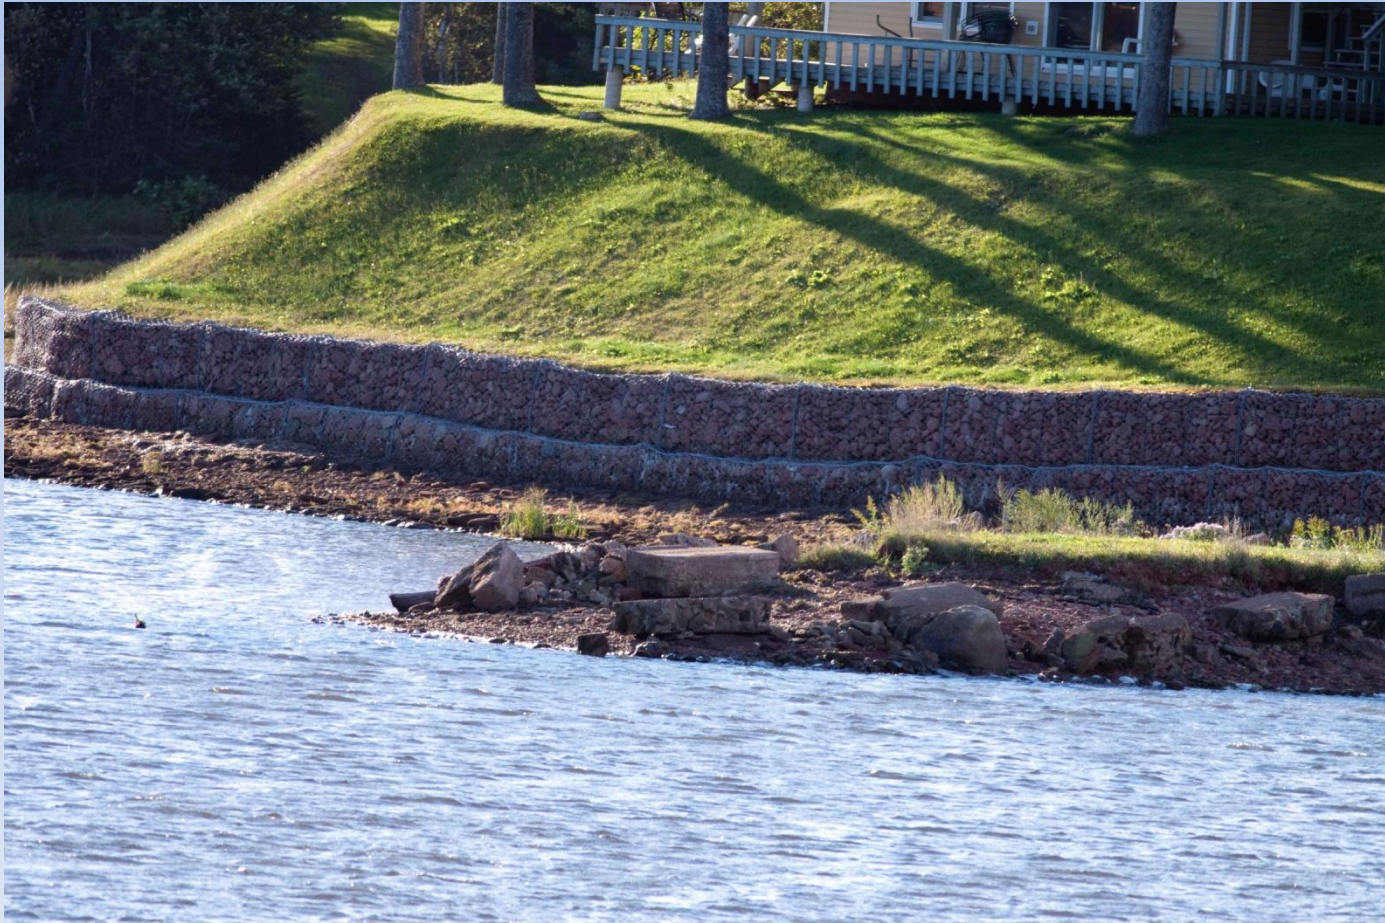
# Gabion - Shoreline Protection at Cascumpeque – hard method

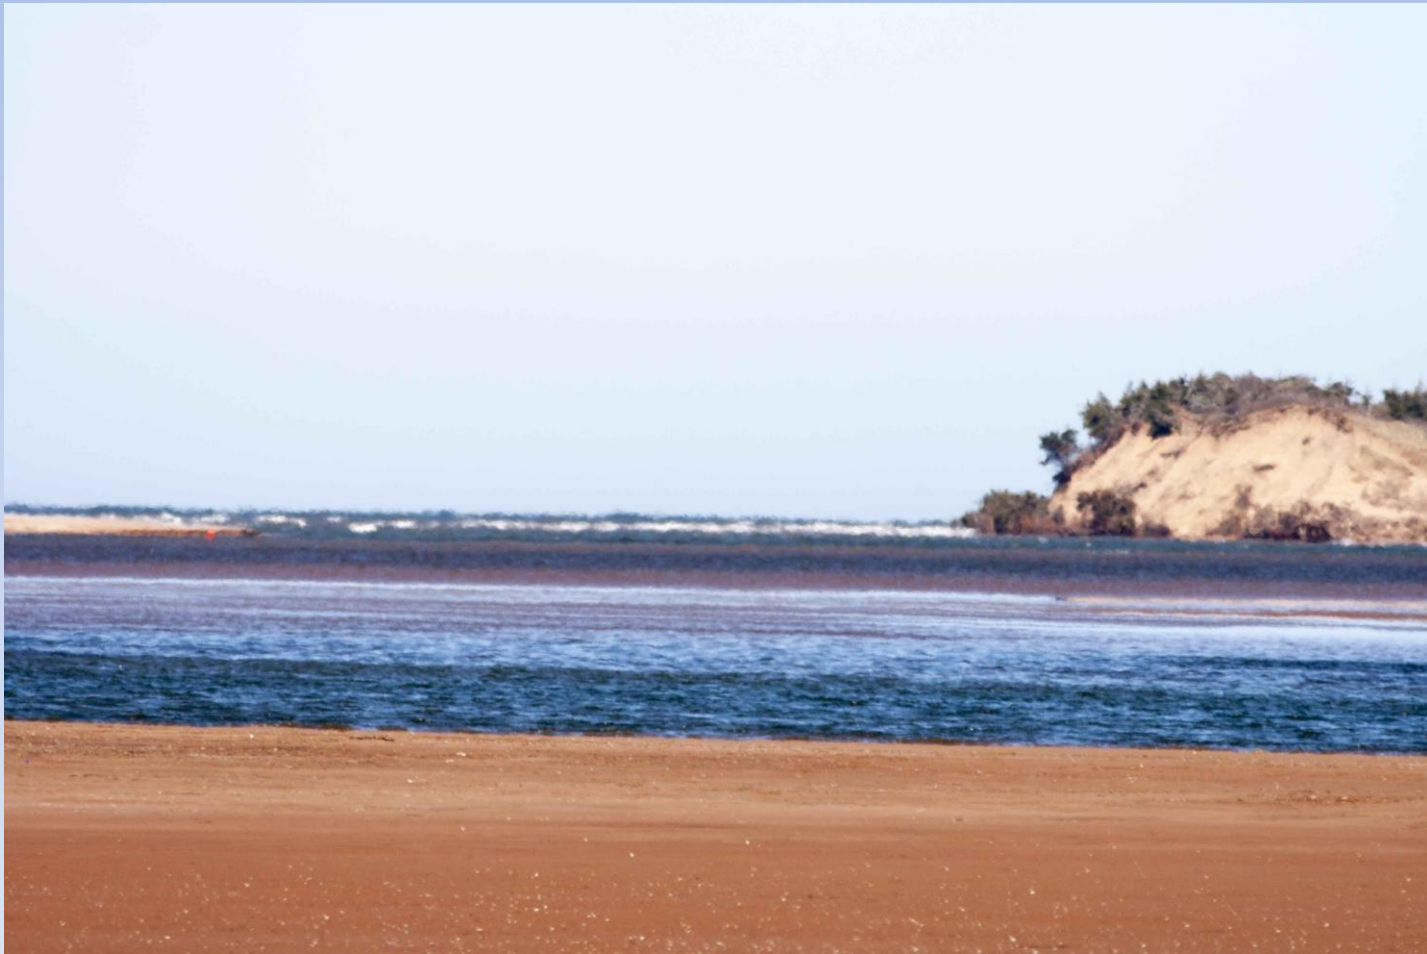
Breach of Dunes at Head of Tracadie Bay = More wave energy in the Bay

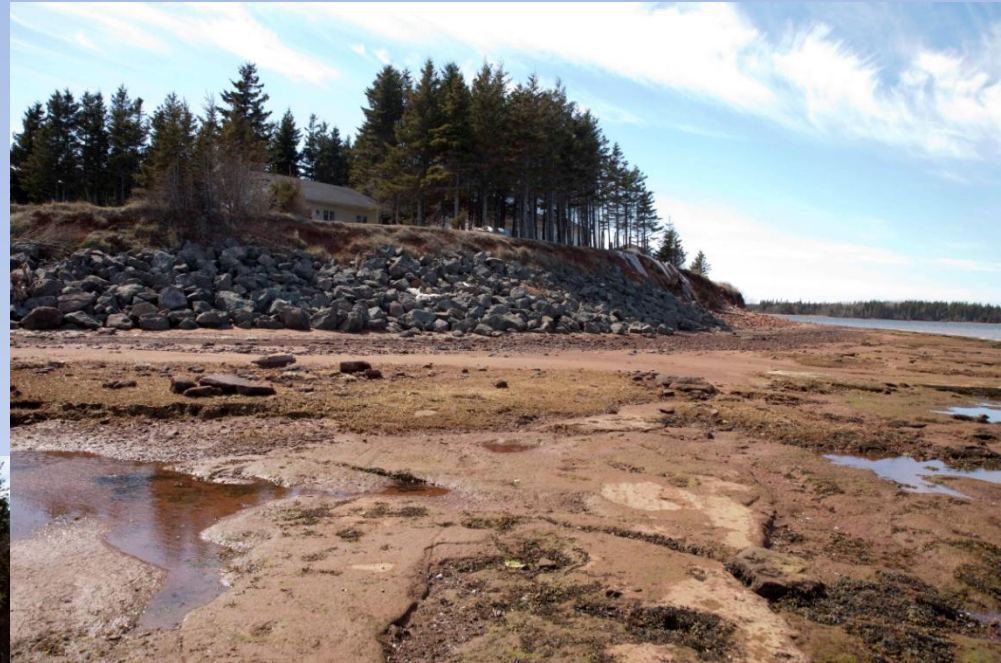
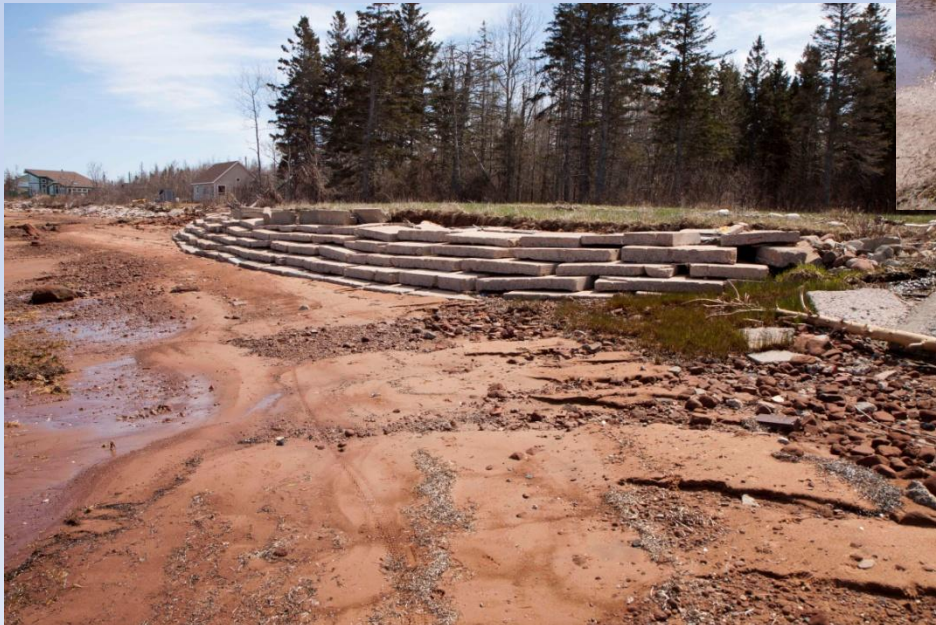
# Winter Bay Shoreline Protection

- Armour rock
- Concrete slabs

- Shoreline is under wave attack during surges
- Erosion occurring in non-protected areas
- Many types of protection installed
- Most are not high enough to withstand highest waves – min. 3.5 to 4.0 metres above MSL.
- Several are not installed properly
- Need for a harmonized approach
- Design standards need to be established
- Education of shorefront property owners is req'd
